30 Hector Gate Dartmouth, NS Curtain Wall Repairs

Centrecorp Management & CREIT

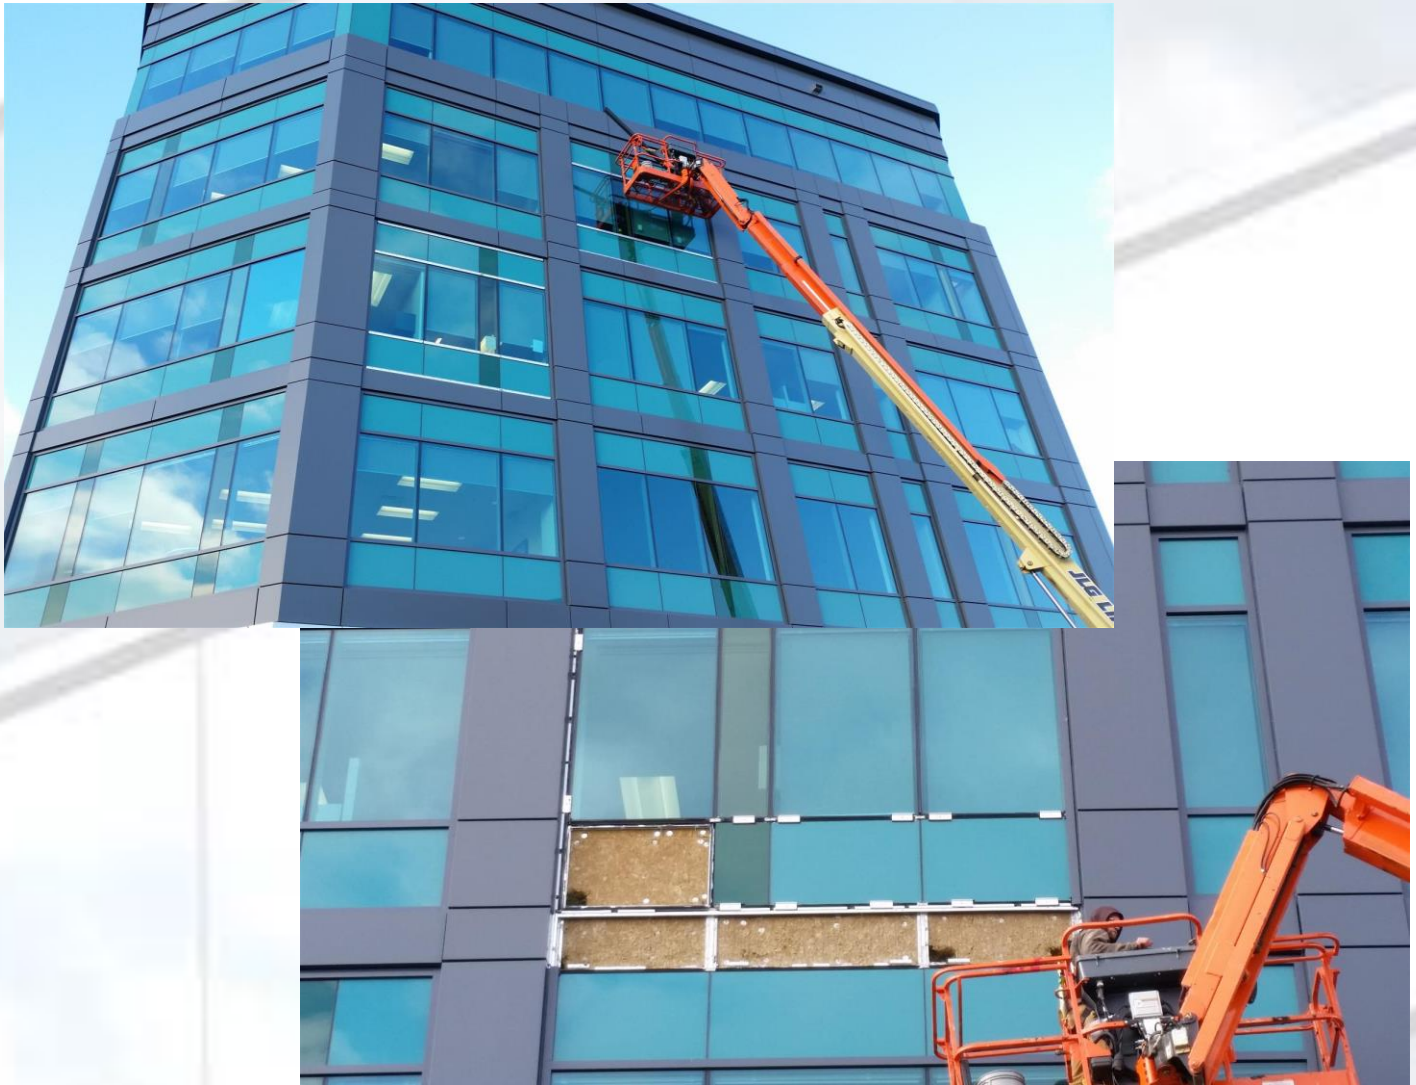
A curtain wall water leakage evaluation was completed on this 5-storey commercial office building. The walls are clad with an ANOTEC 3400HP Series stick-built curtain wall system and are glazed with insulating glass units (at vision areas) and insulated backpans and aluminum composite material (ACM) panels at spandrel locations.

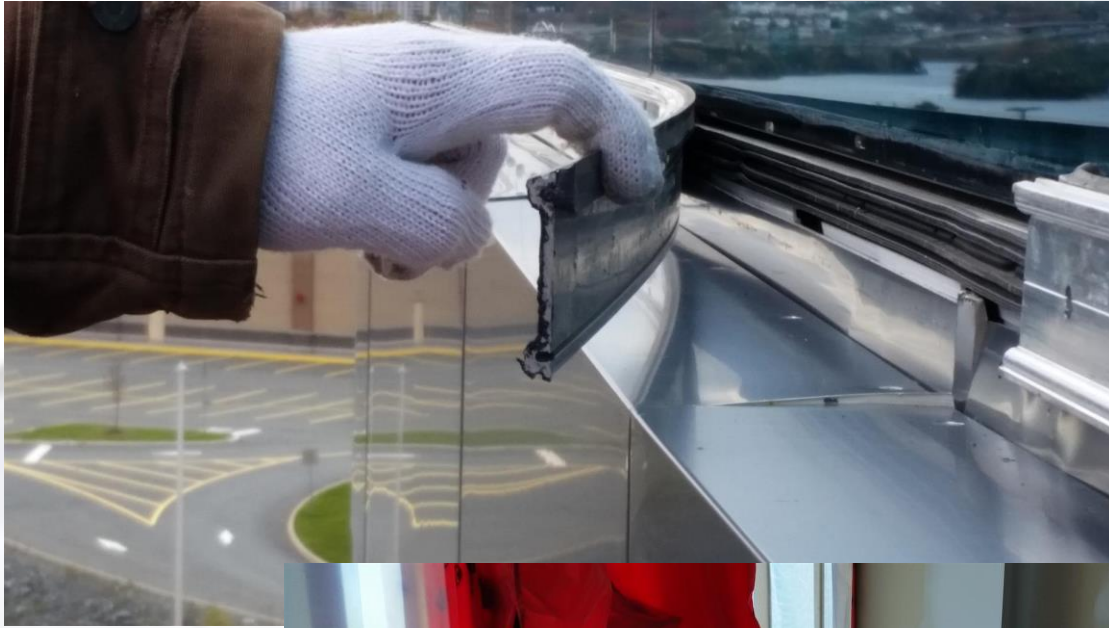
The evaluation included a review of the architectural drawings, curtain wall shop drawings, ACM panel shop drawings, curtain wall design specifications, and ACM design specifications and a visual review of the curtain wall system on the southeast, northeast, and north elevations via boom truck.

A review of disassembled curtain wall components and ACM spandrel panels was completed at targeted locations on three elevations to review concealed detailing and conditions. Synergy developed repair specifications, reviewed repair work, and completed water testing to check repair effectiveness.
